Manhole Inspection Summary

Manhole # S57E__025MH

Insp Date: **6/30/08 2:06 PM**

Location Address: **4329 e lombard st**

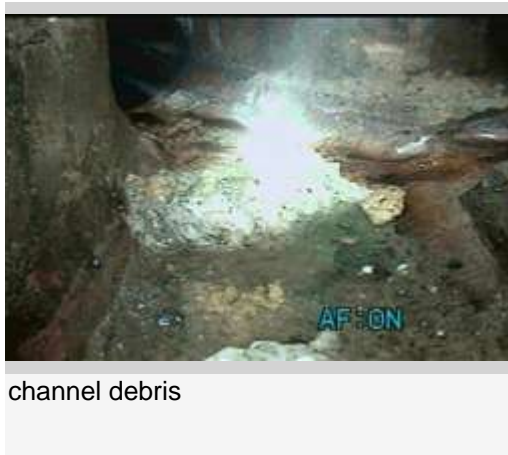
Misc

channel debris

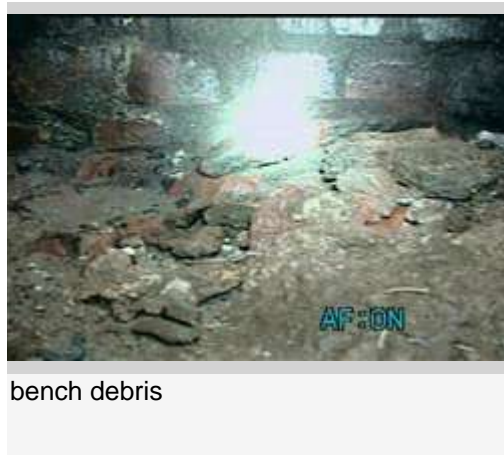
Misc

bench debris

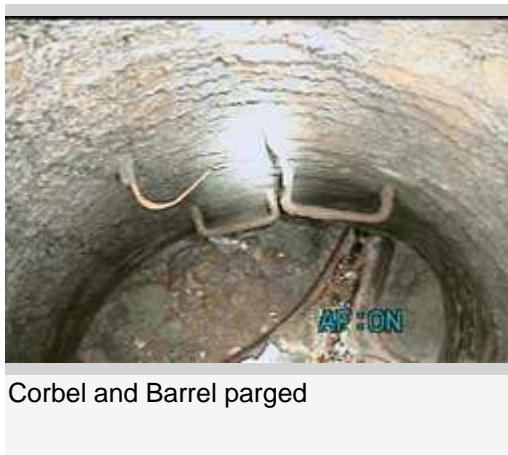
Miscellaneous

Corbel and Barrel parged

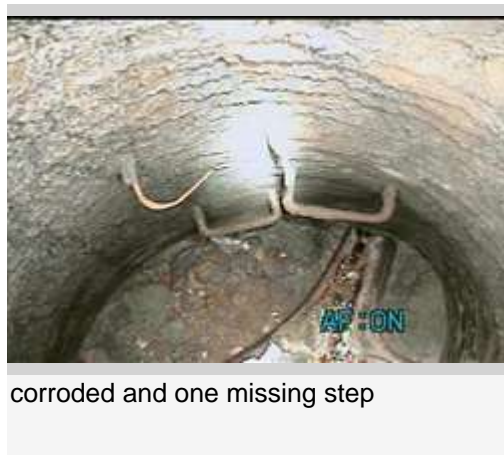
Defect 1

Count: **3**

Missing: **1**

☒ **Corroded**

corroded and one missing step

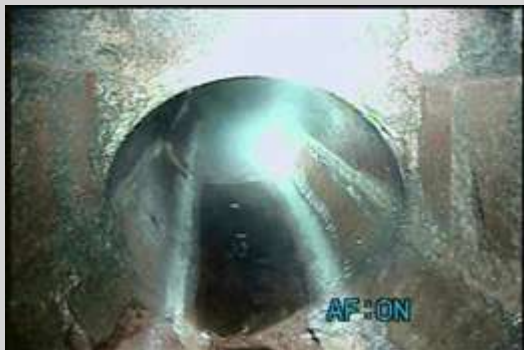
12 O'Clock Outflow

8 in. Circular Gravity Sewer
Pipe Out @ 12 O'Clock

Pipe Material: **Clay** ☐ Pipe Lined

Invert Depth: **9.16** (ft.) Flow Characteristics: **Fast**

Deposits: ☒ None ☐ Mud ☐ Sludge ☐ Debris ☐ Grease

Infiltration: **None** Pipe Seal Cond: **Unknown**

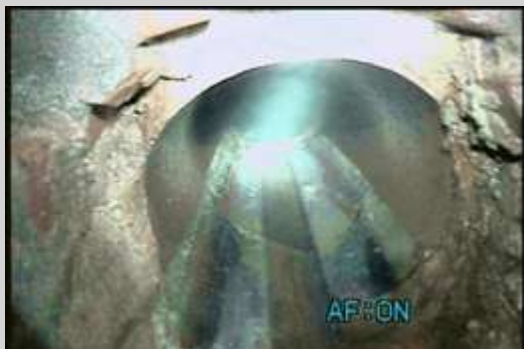
3 O'Clock Inflow

8 in. Circular Gravity Sewer
Pipe In @ 3 O'Clock

Pipe Material: **Clay** ☐ Pipe Lined

Invert Depth: **8.98** (ft.) Flow Characteristics: **Fast**

Deposits: ☒ None ☐ Mud ☐ Sludge ☐ Debris ☐ Grease

Infiltration: **None** Pipe Seal Cond: **Unknown**

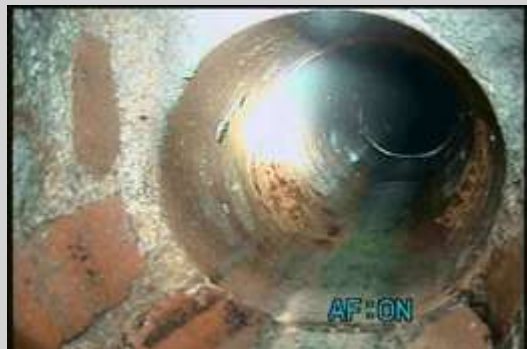
8 O'Clock Inflow

8 in. Circular Gravity Sewer
Pipe In @ 8 OClock

Pipe Material: **Clay** ☐ Pipe Lined

Invert Depth: **9.00** (ft.) Flow Characteristics: **Slow**

Deposits: ☒ None ☐ Mud ☐ Sludge ☐ Debris ☐ Grease

Infiltration: **None** Pipe Seal Cond: **Unknown**
